# Classification, Effects, and Prevention of Build Defects in Powder-bed Fusion Printed Inconel 718

Prepared By: Arthur Brown

NASA

Marshall Space Flight Center

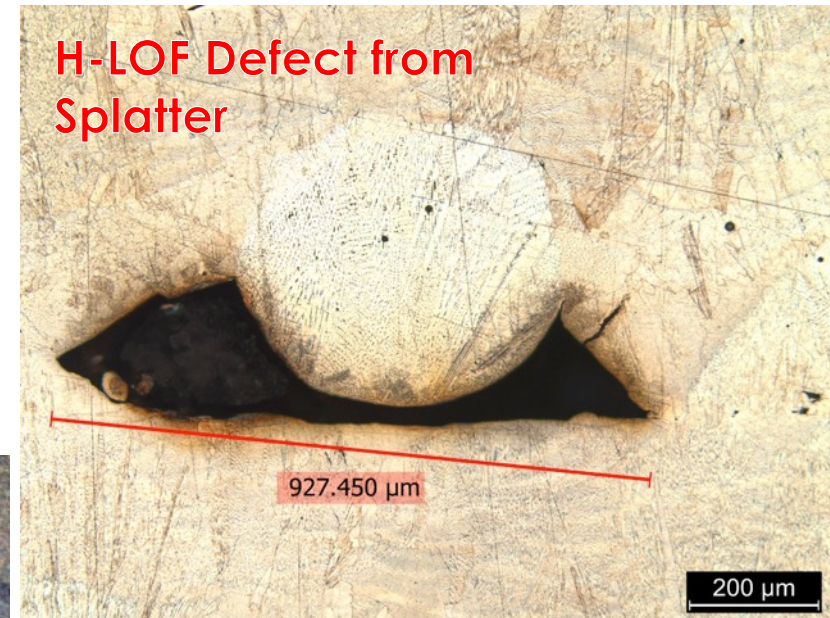
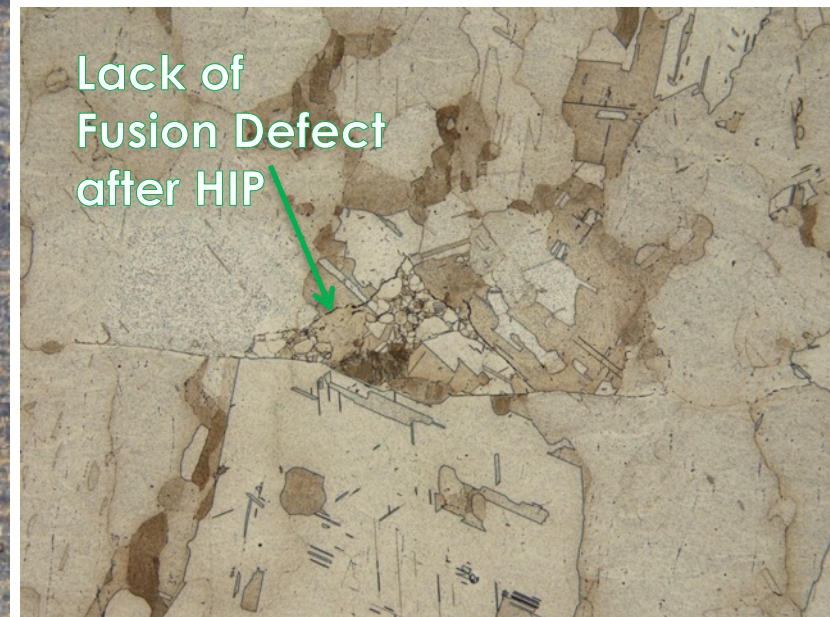
- Horizontal Lack of Fusion Defects are generated in several ways:
  - Low power/high speed settings.
  - An attenuated laser.
  - Splatter falling on surface.
- This type of defect is considered detrimental to mechanical properties.

**H-LOF Defect from Laser Attenuation or Low Energy Density**
